Radiation Tolerant DDL SIU Status Report

Csaba Soós (PH/AID)

Radiation Tolerant DDL SIU - TPC Electronics Meeting, Bergen

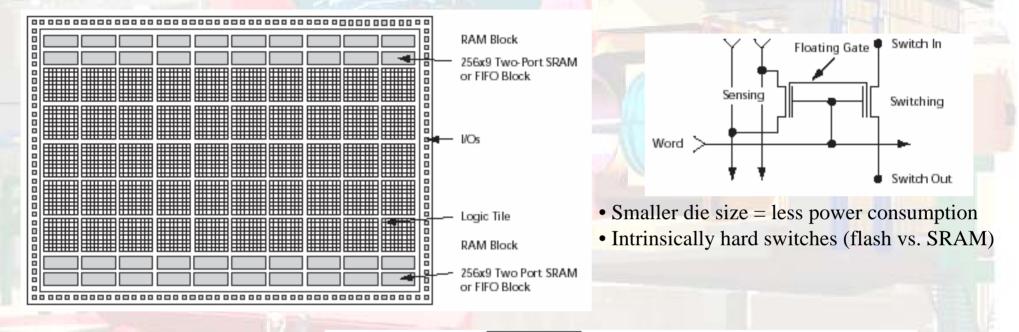
ProASIC+ Architecture

• Any 3-input, 1-output logic function (expect 3-input XOR)

• Register/Latch with clear or set (enable requires additional cell)

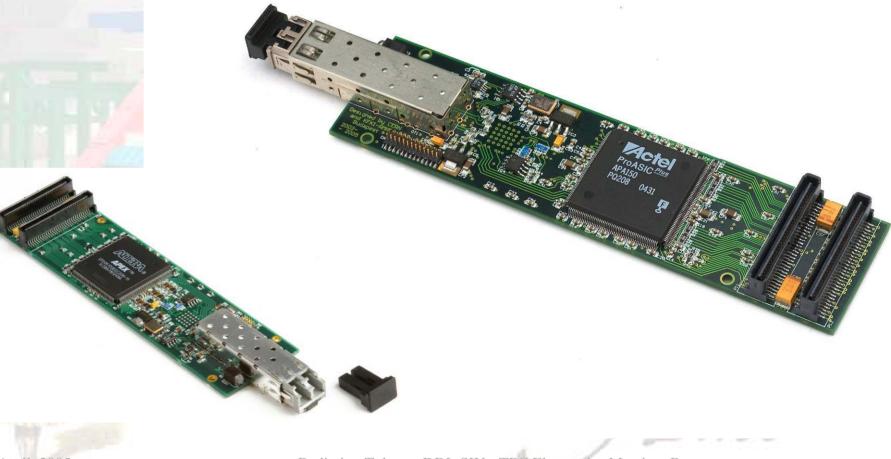
Hardware

100 % backward compatible with the existing DDL cards

• same pin-out, voltage levels and mechanical size

- The schematic was finalized after Actel released the information about the migration from ProASIC+ to ProASIC3
- The PCB has been designed to be compatible with both families
- Two prototype boards have been manufactured
- No design error has been found so far

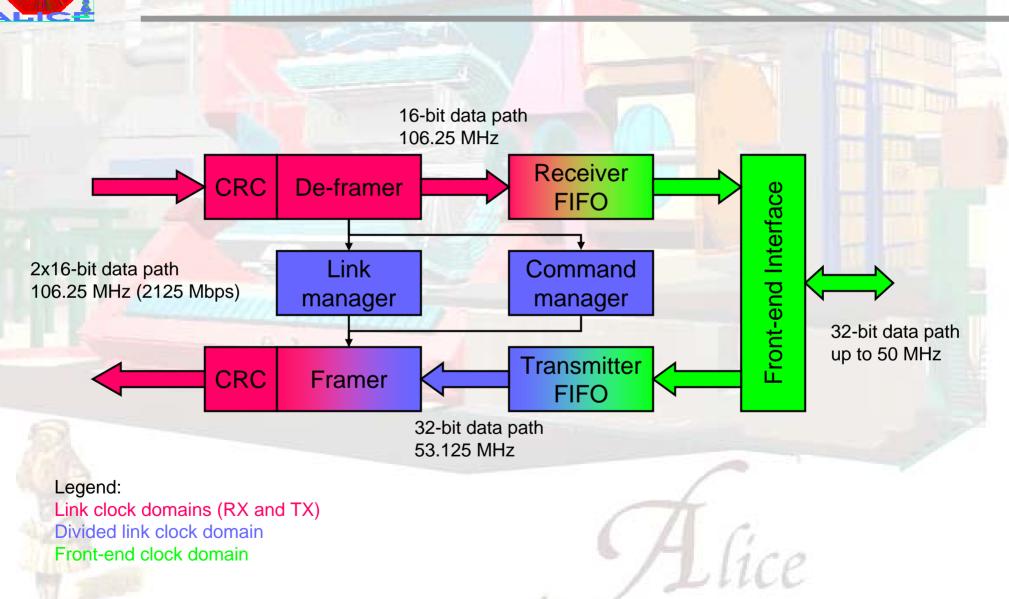
Firmware (2/2)

- Use internal PLL to generate TXCLK/2
 - it fixes the delay between TXCLK and TXCLK/2 clock signals
 - it allows timing budget calculations
- Improve the receiver logic to run at 110 MHz
 - it eliminates the need of the divided clock
- Custom dual-port memory has been designed

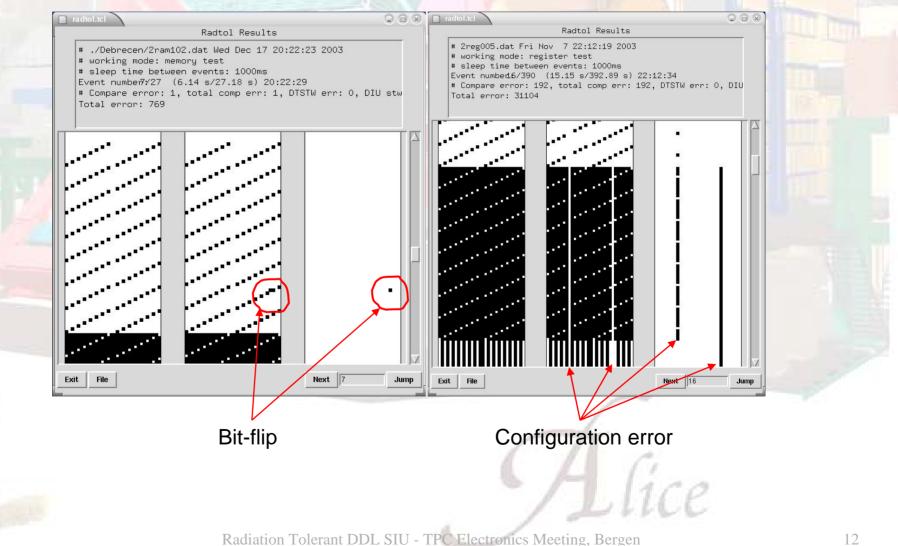
Radtol Tests – Software

• RORC programs have been used to read status and to monitor the link integrity
